WETLAND DETERMINATION REPORT FOR

HI-TECH PROPERTIES

Wetland Resources, Inc. Project #08063

May 5, 2008

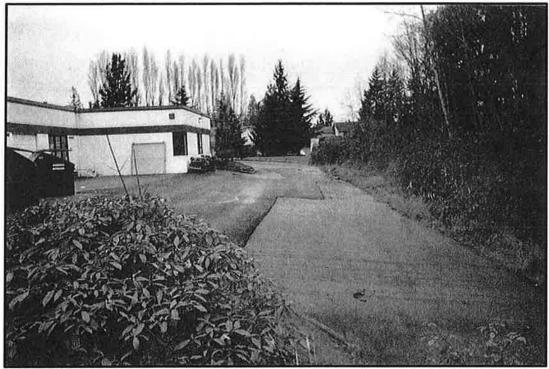
The Quadrant Corporation began development of Quadrant Business Park in 1979. The original plan included eight buildings (A through H) that would be built in several phases. By October, 1981, six of the buildings (A through F) had been constructed and they were working toward permitting the final two buildings (G and H). The design of the final product included drainage infrastructure that would capture and convey surface water from the development to the city's stormwater system. For unknown reasons, buildings G and H were never built. The result was that the parking lot on the north side of building F was only partially constructed, sloping toward the subject

property (see Photo 1 in Appendix A), and the drainage infrastructure was never built to capture stormwater. During precipitation events, surface water flowed directly from the business park onto the subject property and ponding began to occur on a frequent basis, as shown in Photo 2, Appendix A. The property owners complained to the City that a serious drainage problem was damaging their property, but no repair occurred.

PHOTO 1: NORTH SIDE OF BUILDING F WITH PARKING LOT SLOPING TOWARD SUBJECT PROPERTY.

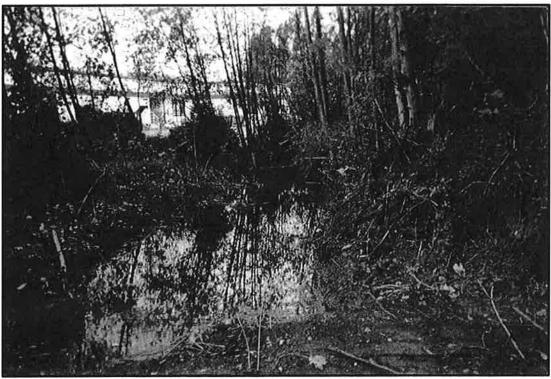
PHOTO 2: BUILDING F IN BACKGROUND. PONDING WITHIN SUJBECT PROPERTY DUE TO SURFACE RUNOFF FROM BUSINESS PARK.

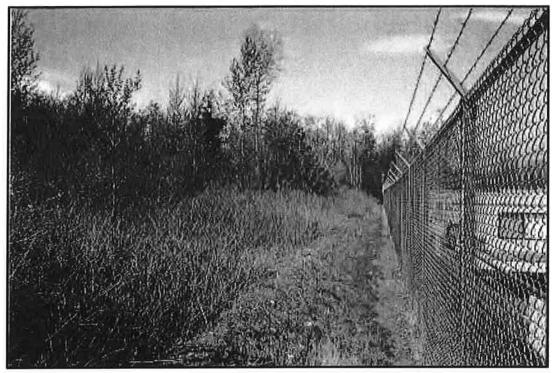
No drainage repairs were undertaken to alleviate the drainage problems from the business park and the lack of drainage facilities was affecting other area properties. In response, Whyte's Shelter Storage, which lies due east of the subject property, constructed a berm along the eastern boundary of the subject property to prevent surface water from flowing onto their property (see Photo 3, Appendix A). Due to the topography of the area, the compacted berm caused all of the surface water from the business park to be impounded on the subject property, thereby increasing the burden on the property owners.

PHOTO 3: BERM ALONG EAST SIDE OF SUBJECT PROPERTY, LOOKING NORTH. WHYTE STORAGE TO RIGHT.

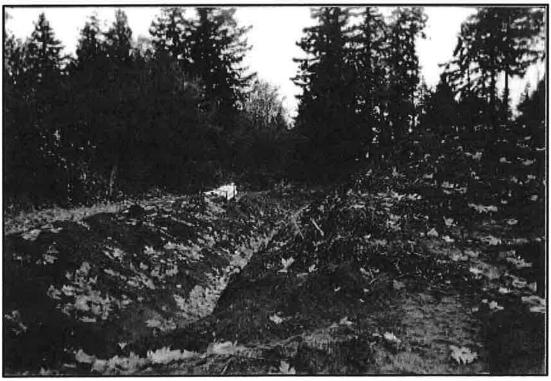
In preparation for construction of the City of Mukilteo's Public Works facility, city crews began dumping spoils from street sweepers on the 80th Street SW right-of-way (see Photo 4, Appendix A). The spoils were intended to create a road bed for an entrance on the south side of the Public Works facility. At the same time, a culvert that had long conveyed hydrology under 80th Street SW was removed (see Photo 5, Appendix A) and replaced with another in a different location and at a higher elevation. At some point in this operation, it was determined that the sweeper spoils were not appropriate for the road foundation and they were removed. The replacement culvert was removed and again replaced in a different location and at an even higher elevation (Photo 6, Appendix A). The second replacement culvert is estimated to be at least two feet higher than the original culvert. In addition, a ditch that was located along the south side of 80th Street was filled and not rebuilt. These actions, combined with the berm that had been constructed by Whyte's Shelter Storage in 1989, caused serious water impoundment on the site.

PHOTO 4: STREET SWEEPER SPOILS DEPOSITED ON 80TH STREET SW RIGHT-OF-WAY, LOOKING WEST.

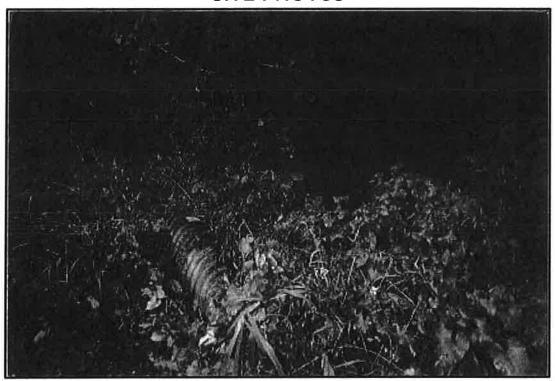
PHOTO 5: ORIGINAL CULVERT FROM 80TH STREET SW.

- Along the north side of your property: The City of Mukilteo reportedly removed a culvert, filled a ditch and dumped an over 6-feet-high pile of street sweeping waste along the north boundary of your property. The City apparently replaced the removed culvert but at a higher elevation than the culvert they removed. While the pile of dumped material was present, it likely acted to further block water from draining off of your property. In addition, although most of the dumped material has since been removed by the City, the activity appears to have compacted the soils which has also blocked water drainage from your site. Furthermore, during the City of Mukilteo's recent development of their property, the contractor allegedly filled the ditch and removed the culvert again. The contractor then replaced the culvert again at a much higher elevation than before. The ditch has not been re-dug. Together these actions appear to have created a back up of water in the northeast corner of your property.

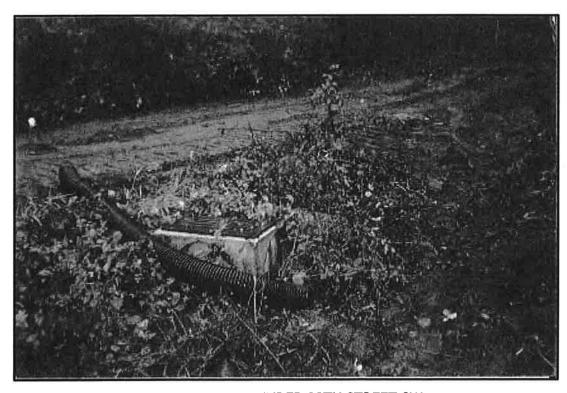
Based on the evidence provided, it is readily apparent that the subject property did not historically contain any wet areas. The artificial drainage that has been directed onto the site, along with the improper construction of 80th Street, have created areas of ponding that could turn into wetlands over time. The relocation of culverts during the construction of 80th Street appears to be the most direct cause of impounded water, since it can no longer drain to the northeast.

PHOTO 6: REPLACEMENT CULVERT UNDER 80TH STREET SW.
